**Subject: Final Emergency Response Letter Report
Port Wentworth Caustic Spill
Port Wentworth, Chatham County, Georgia
EPA Contract No. EP-W-05-054
TDD No. TTEMI-05-001-0085**

PORT WENTWORTH CAUSTIC SPILL
PORT WENTWORTH,
CHATHAM COUNTY,
GEORGIA
TDD No. TTEMI-05-001-0085

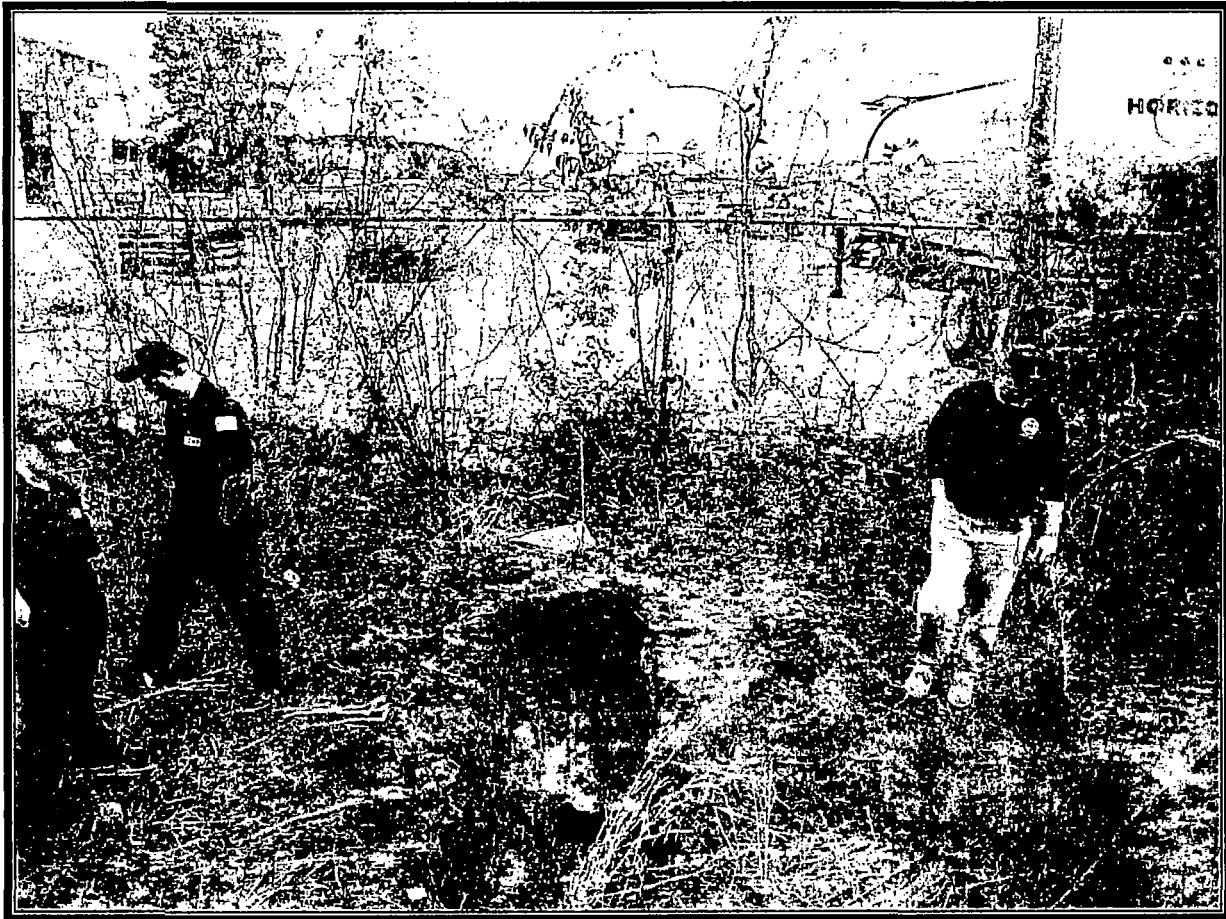
OFFICIAL PHOTOGRAPH NO. 1
U.S. ENVIRONMENTAL PROTECTION AGENCY

Subject: Suspected point of entry in the fence line ditch along the north side of the Horizon Tank Lines facility. This location corresponds to field testing location FT-20. Note the dark liquid in the bottom of the trench. Field testing conducted by Tetra Tech START indicated a pH of 13 for the liquid.

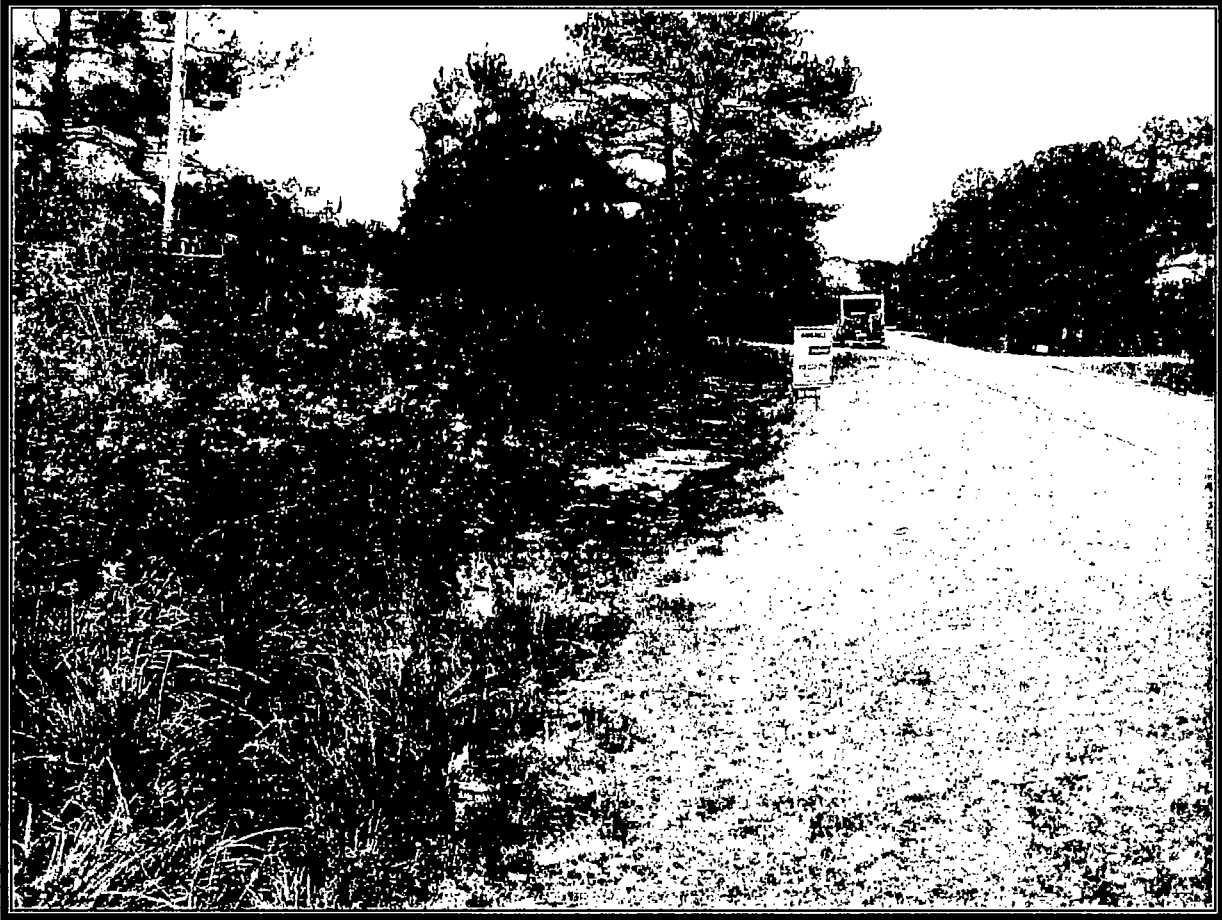
OFFICIAL PHOTOGRAPH NO. 4
U.S. ENVIRONMENTAL PROTECTION AGENCY

Subject: The O'Leary Road ditch at the confluence with the fence line ditch following initial excavation activities that were performed by Moran Environmental Recovery under contract to the U.S. Coast Guard.

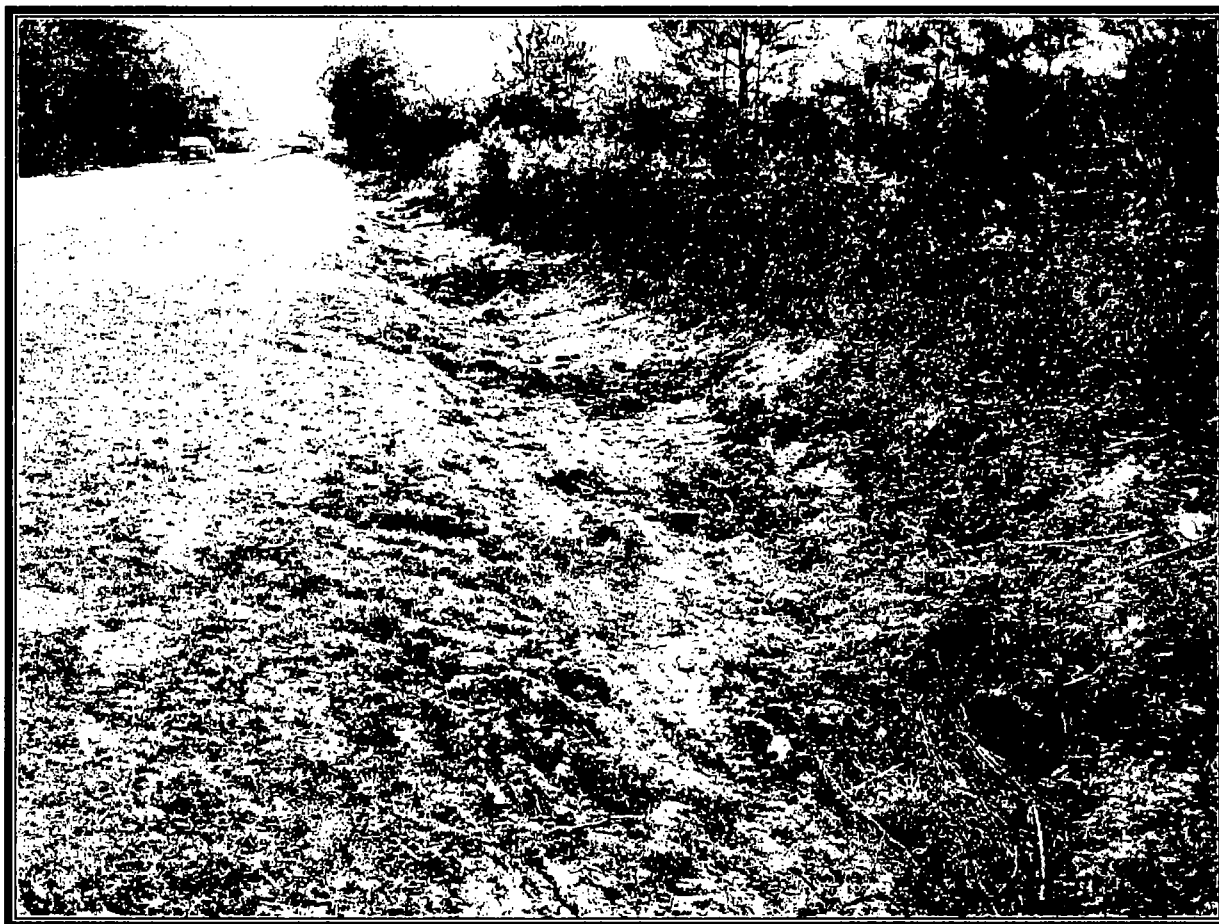
OFFICIAL PHOTOGRAPH NO. 8
U.S. ENVIRONMENTAL PROTECTION AGENCY

Subject: O'Leary Road ditch downgradient from its confluence with the fence line ditch. Note the white residual material that formed on the surface. Field testing conducted by Tetra Tech START indicated a pH of 12 to 13 for the white residual material.
